Manhole Inspection Summary

Manhole # S13M__002MH

Insp Date: **1/21/09 10:19 AM**

Location Address: **200 Font Hill Ave.**

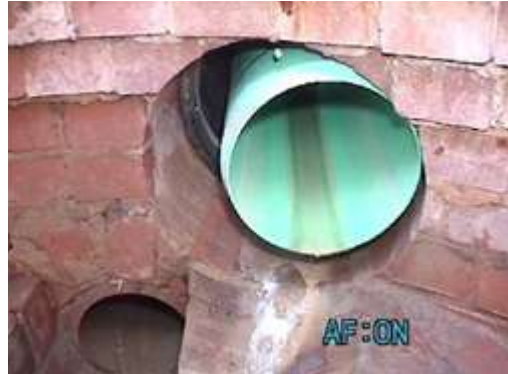
Miscellaneous

Pipe IN @ 4 O'clock. Appears to be Service line

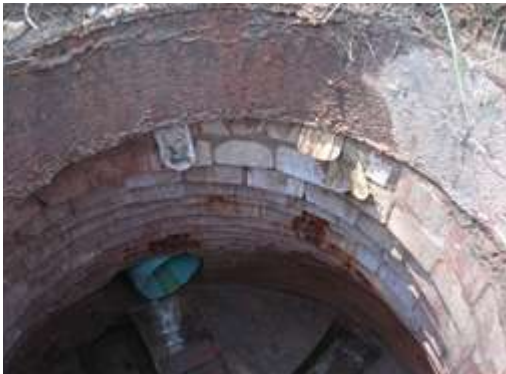
Defect 1

Frame Offset: **1.5** (in.) Condition: ☒ Sound ☐ Cracked ☐ Leaks

Surcharge ☒ **Evidence Of Surcharge** Depth: **2** (ft.) ☐ Active Surcharge Present

frame offset & surcharge evidence

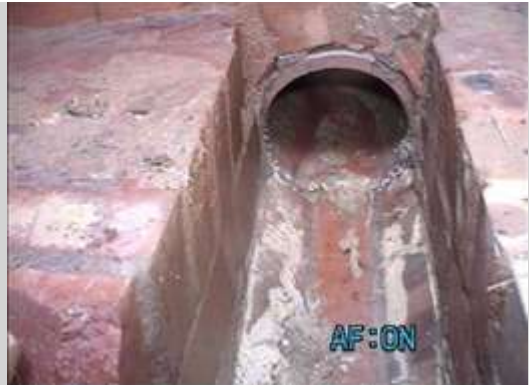
6 O'Clock Inflow

0 in. Circular Gravity Sewer
Pipe In @ 6 O'Clock

Deposits: ☐ None ☐ Mud ☐ Sludge ☒ **Debris** ☐ Grease

Silt Depth: **7** (in.) Deposits Extent: **Heavy**
